4. MATERIALS AND ASSEMBLIES

4.1 Methodology

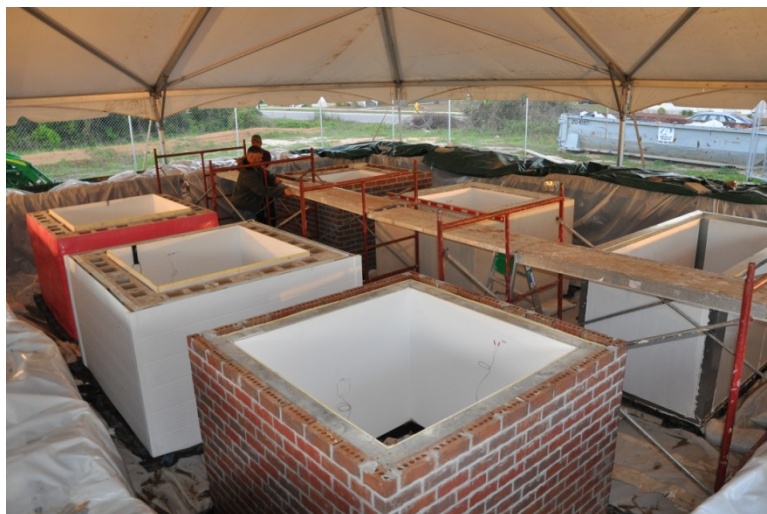
Fig. 4.3. PHOTO: Flood tank prior to flood simulation 1.

The flood tank (see Fig. 4.2) was constructed using Hesco Bastion Containers, otherwise referred to as Hesco boxes. Hesco boxes are welded wire mesh boxes with a geotextile lining for sand or gravel fill. Each box has a 3' by 3' base and is 4' tall, linked together to create a 4' tall 40' by 40' test tank. After the test fill, the tank was lined with heavy plastic sheets to increase its ability to hold water. A walkway was installed for easy access and observation of the test pods. A large open air tent was installed over the tank (see Fig. 4.3) during the flood simulation and drying period.

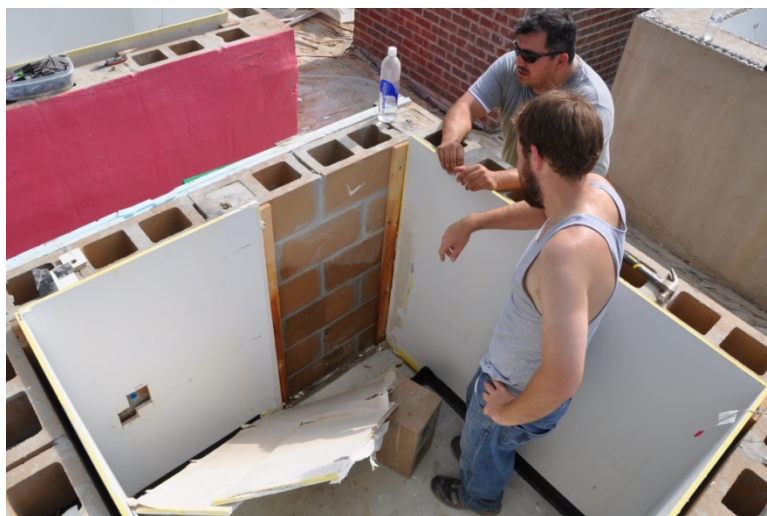
Fig. 4.5. PHOTO: Partial demolition of test pod after flood simulation 1.

During flood simulations, GCCDS staff members were able to monitor results through measuring water depths inside the test pods, through photographing and videotaping the flood simulations, and through creating a written record of changes in test pod performances. Observations continued as the tank was emptied and water from inside the test pods drained out of the assembly. A two-week drying period followed the first simulation during which moisture content sensors and relative humidity sensors were embedded at various points and depths in the test pods. The final step of the observation protocol was to disassemble several portions of the test pods to look for possible moisture points of intrusion (Fig. 4.5).

The graph shows that the concrete dried very little during the two-week drying period. The moisture levels in the concrete were similar to the moisture levels found in test pod A: sealed block. Likely, this is because the concrete still had high moisture content from being poured approximately a month before the testing began. However, neither of data sets gathered from the concrete in test pod B fluctuated similar to the data sets gathered from the concrete materials in test pod A: sealed block. An explanation for this difference may be that while the concrete materials in both test pods were holding the maximum amount of moisture the material was capable of, (100% reading) the concrete products in test pod B: cavity wall were also surrounded by water, as water was trapped within the assembly. This explanation was supported by evidence of water found within the interior of other CMU block walls during partial demolition (Fig 4.5).

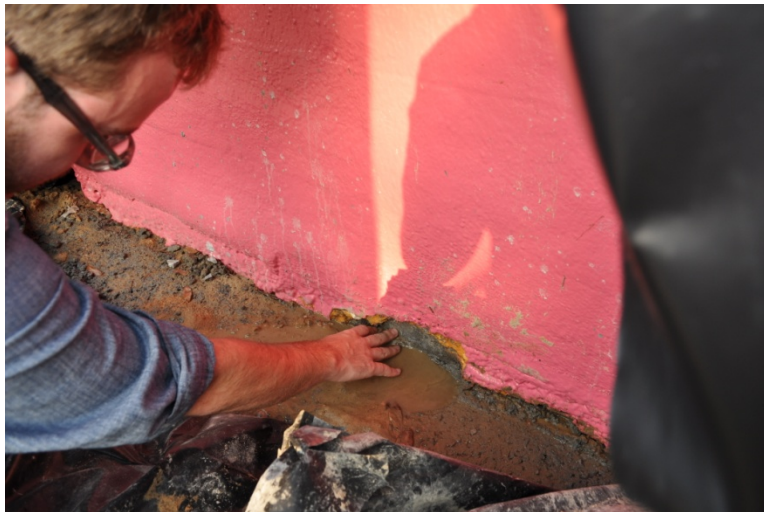
Fig. 4.19. PHOTO: Damage to test pod A: sealed block during the test fill.

During the test fill a water depth of 36" within the tank could not be maintained for an entire 24 hour period. Water leak through the tank lining and Hesco boxes at a high rate making it too difficult to maintain proper depth. Only pod A: sealed block had been installed at the time of the test fill. The interior water depth in the test pod was 2" after 20 hours of flood simulation at water depths ranging from 24" to 40". After the flood tank had been evacuated, an inspection of the exterior coating of test pod A: sealed block revealed that a 6"x 2" strip of the layered polymer membrane had broken off the wall near the bottom (Fig.4.19). This hole in the sealant material was patched using the same liquid-applied asphaltic sealant used in test pod B: cavity wall, prior to the next flood simulation.

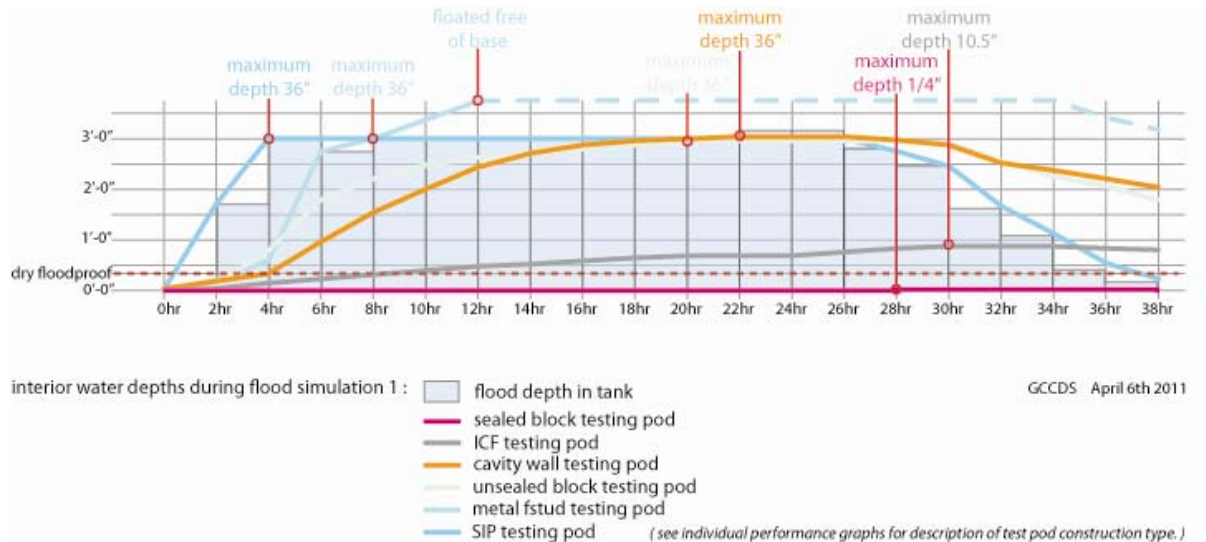
Fig. 4.20. GRAPH: Interior depths: flood simulation 1.

The following is a condensed version of the report from flood simulation 1, which highlights the significant events during the simulation. For a more complete report of the simulation see Appendix A: “Full Test Results”. Above (Fig. 4.20), a graph shows the interior depths that infiltrated the test pods during the flood simulation 1.

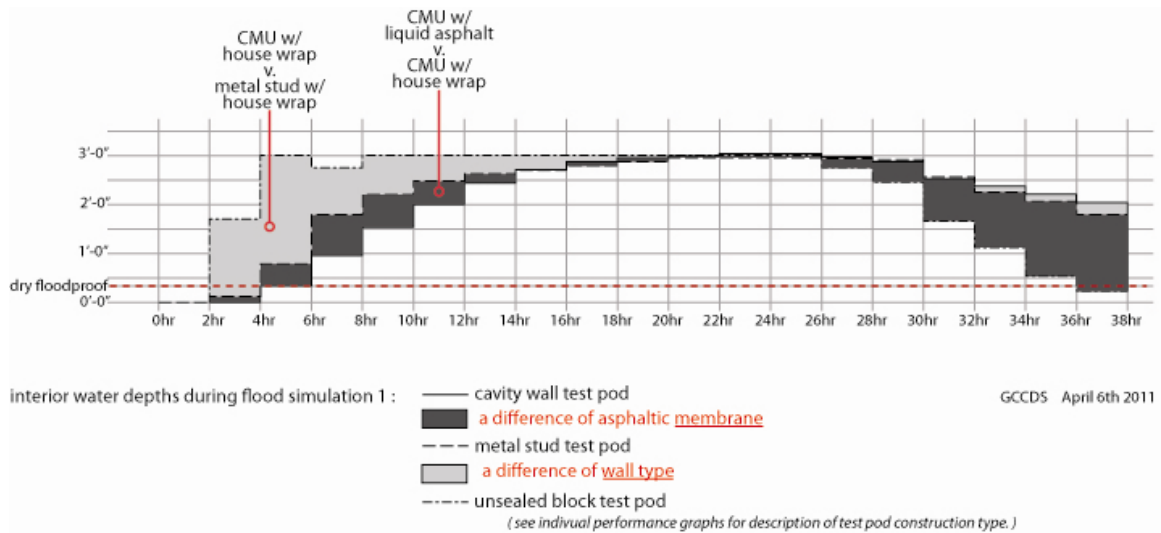
Fig. 4.24. GRAPH: Int. depths: differences between membranes and wall assemblies.

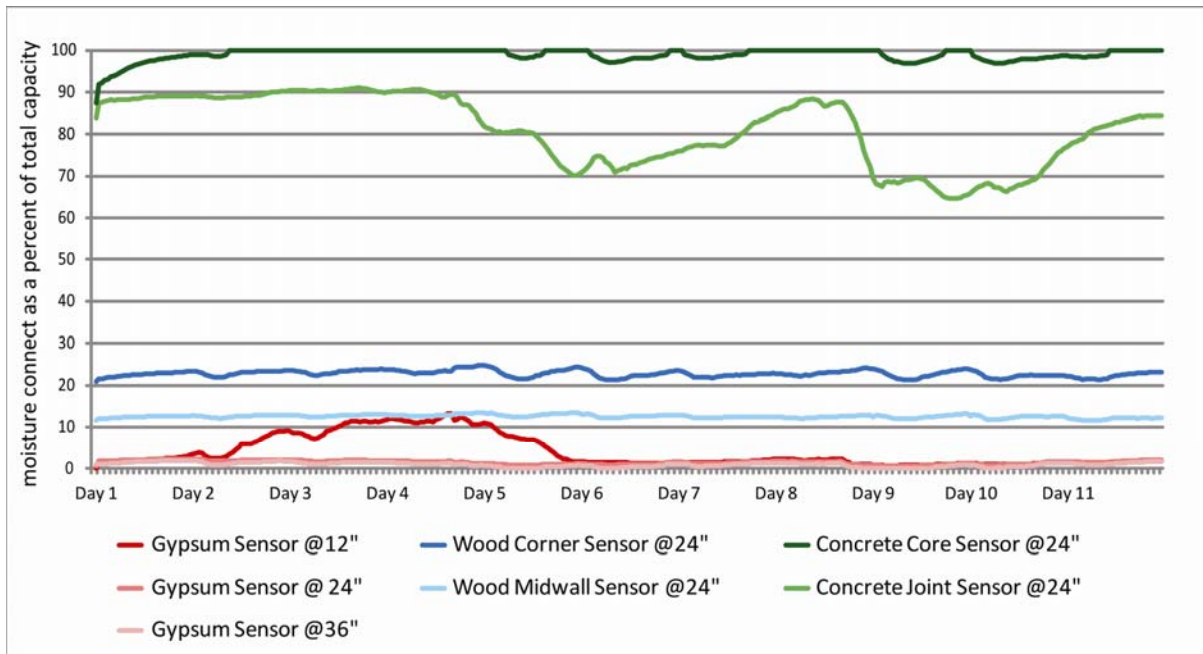
Fig. 4.28. GRAPH: Drying period test pod A: sealed block, flood simulation 1.

The sensor readings for test pod A: sealed block are exemplary of the moisture levels within an assembly classified as dry floodproof (Fig 4.28). This sensor reading data provides information regarding the moisture collection within an assembly. The concrete sensors (upper green lines) show that the concrete dried little during the two-week drying period. The fluctuations in the moisture level of the concrete cavity sensor represent daily temperature change. The concrete joint sensor fluctuates similarly, however over a two-day cycle. The cause of this is unclear. The wood sensors were placed between the interior face of the CMU block wall and the backside of the gypsum board, embedded into the wood furring strips. The readings (middle red lines) show that the moisture level within the furring strips hovered around 10% and 20% for the duration of the drying period. However, these post-flood moisture levels match the pre-flood moisture levels, indicating that the moisture content was constant and unrelated to the flood simulation. The average moisture content for all wood products in the test pods prior the flood simulation was 12%.

The lower blue lines in the graph represent the three moisture sensors embedded at various heights into the gypsum board. Sensors were placed at 12", 24" and 36" above the slab, aligned vertically (Fig. 4.29). Since only .25" of water penetrated the interior of

the pod, none of the gypsum sensors were in direct contact with water during the flood simulation. The increase in moisture content reading from the gypsum sensor embedded 12" above the slab is most likely the result of water wicking, as a result of capillary action, from the base of the gypsum board. Note that it took several days for the moisture to migrate to this height, and subsequently dried out within one week. Moisture was not able to reach the height of sensors at either 24" or 36". These results are constant with the gypsum data shown in subsequent readings.

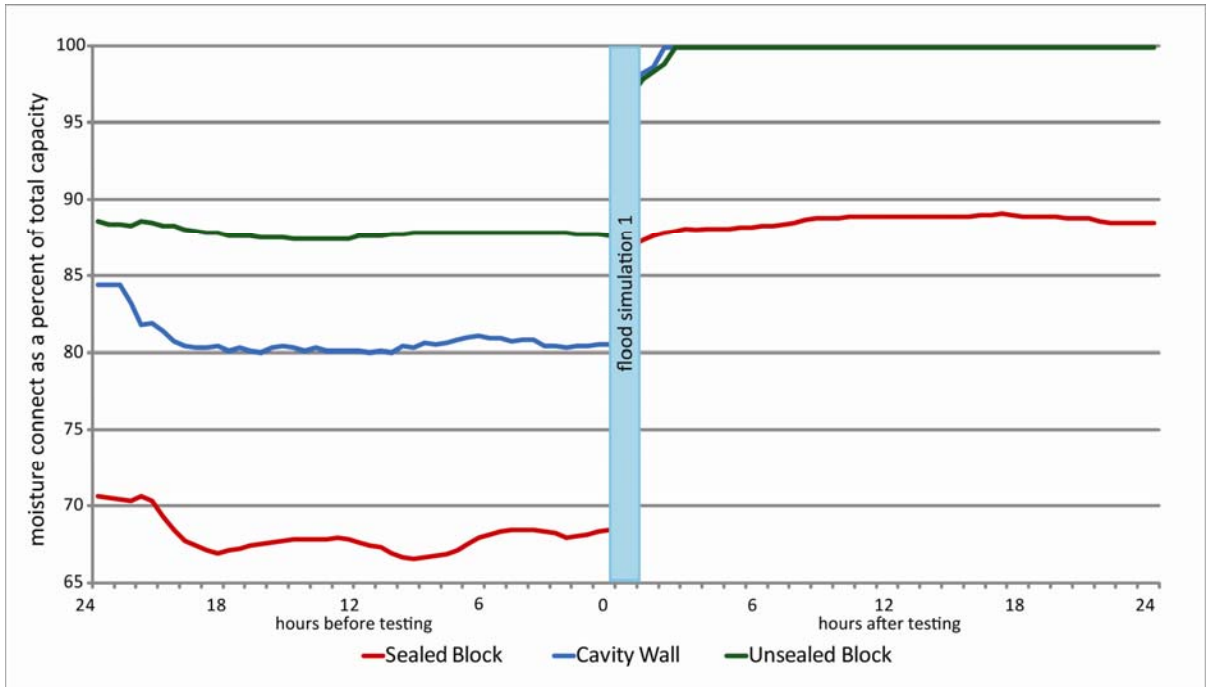
Fig. 4.32 GRAPH: Moisture levels in mortar: before and after flood simulation 1.

Fig. 4.32 shows the data collected by sensors embedded in the mortar joints of three test pods for 24 hours before and after the flood simulation. The data collected from test pod A: sealed block shows that even though the test pod demonstrated interior depths compatible with dry floodproof construction, the cement-based products in the wall accumulated additional moisture during the flood simulation. Mortar joints in the other two test pods behaved similarly to each other. While in all cases an approximate increase of 15 percentage points is recorded after the flood simulation, in the case of materials which were fully submerged during the flood simulation, the mortar material reached a level of 100% moisture content. Data from sensors embedded in submerged materials showed the mortar material maintaining a 100% moisture content during the entire two-week drying period. It is unclear how long drying period would have had to continue to record some amount of drying in these materials.

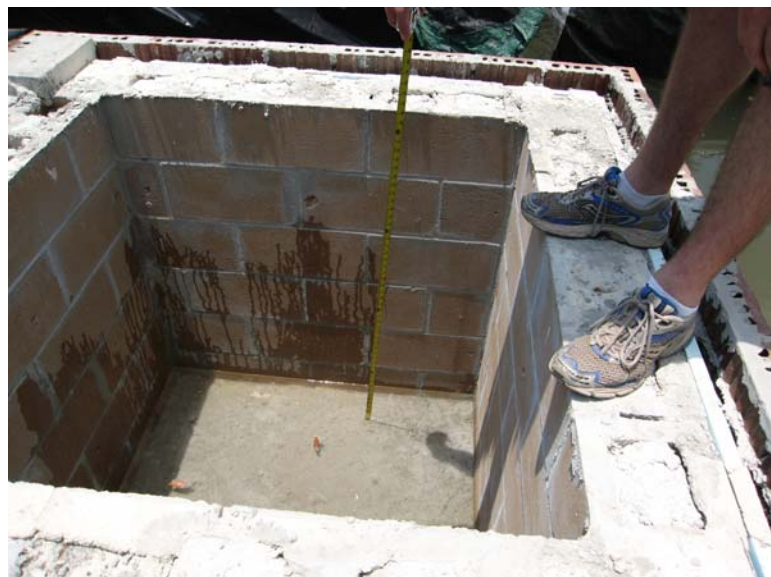
Fig. 4.39. PHOTO: Water seeping into test pod B2: cavity wall filled block, flood simulation 2.

Throughout the second flood simulation, water was observed collecting on several interior faces of the CMU wall, as shown in Fig. 4.39. This accumulation of water was more evident on CMU blocks where cells which had been previously filled for flood simulation 1, rather than those cells which were filled as part of the assembly revisions in flood simulation 2. Despite the improvement in performance in flood simulation 2, this assembly is not a viable option dry floodproofing.
